MONTHLY INSPECTION AT IMAGE (CBWTF), MALAMPUZHA

Date: 12-10-2022, Wednesday

Inspected by: Sruthi Chandran AE-1

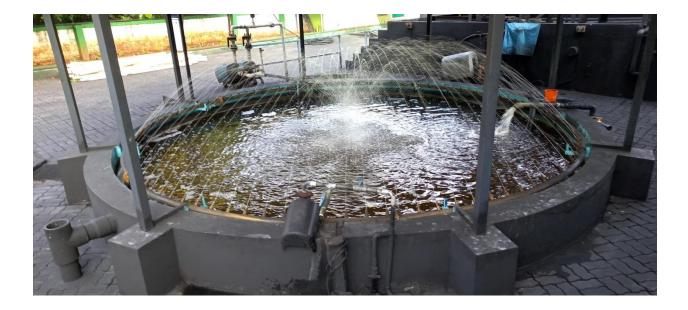
ETP OUTLET

13.	Sample Analysis	Collected on 14.09.2022	
	Results	Filter feed tank	ETP outlet
		pH-8.41	рН- 8.33
		TSS – BDL	TSS-BDL
		BOD – 12.8	BOD-6.6
		COD - 40 mg/L	COD-16 mg/l
		Oil & Grease – BDL BDL	Oil & Grease-
14.	Hazardous Waste Incinerator Ash & ETP Sludge	Stored in Roofed Area – Almost full (Collected by KEIL)

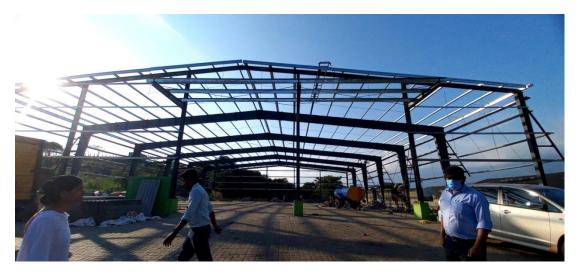
Proposed Site for Barcode Scanning

Sl No.	DETAILS	STATUS / REMARKS	
1.	BMW Collection	51.7 MT (Average collection daily of September)	
2.	Incinerators	1- Shut down for maintenance ; 2,3,4,5 – Working	
3.	No. of Incinerators	5	
4.	Online Continuous Emission Monitoring System (OCEMS)	OCEMS No.1 – New Rotary (Dry Scrubber) – Plant No.1 OCEMS No.2 – Old Parishudh – Plant No.1 OCEMS No.3 – Old Rotary – Plant No.2 OCEMS No.4 – Thermax – Plant No.2 OCEMS No.5 – New Alpha – Plant No.3	
5.	Barcode Scanning	Equipment Dismantled, Not in Use. The shed had caught fire. It is not fully rebuilt; scanning not done. Weighing using weigh bridge is functional; hence weight of BMW handled is obtained.(Letter

submitted on 17.10.2022 that bar coding will be functional soon: letter is attached)	
6.	Unit Premises	Neat & Tidy	
7.	All Plastic Items, Synthetic Rubber Items, Metals, Glass Bottles, Other miscellaneous items	Sent to Aryaja Industries, NIDA, Kanjikode	
8.	ETP	Working, Ultra Filtration(UF) not working.(Last effluent sample was conforming to limits even without UF)	
9.	Online Continuous Effluent Monitoring System (OCEMS)	Working; Partial connectivity shown in OCEMS as one incinerator is not uploading values (maintenance)	
10.	Rain Water Harvesting Pond	Three-Fourth full (no over flow seen)	
11.	Backlog	NIL	
12.	Sample collected for Analysis	Collected from:- (i) Filter feed Tank (ii) ETP Outlet
