MONTHLY INSPECTION AT IMAGE (CBWTF), MALAMPUZHA

Date: 14-09-2022, Wednesday

Inspected by: Sruthi Chandran AE-1, Arya Sidharth - GEA

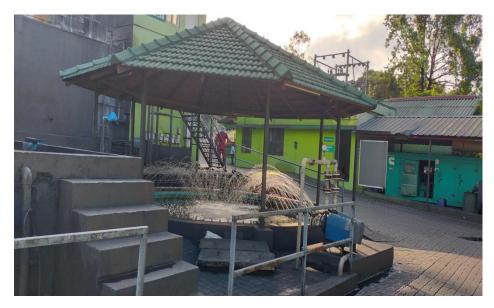
ETP OUTLET

All the parameters are within limit in ETP outlet.
14.	Hazardous Waste Incinerator Ash &	Stored in Roofed Area –
	ETP Sludge	Regularly collected by KEIL.
