KERALA STATE POLLUTION CONTROL BOARD

Sub:- Inspection report of the month of April.

MONTHLY INSPECTION AT IMAGE (CBWTF),
MANTHURUTHY, PALAKKAD DISTRICT.

Date: 25-04-2023, Tuesday

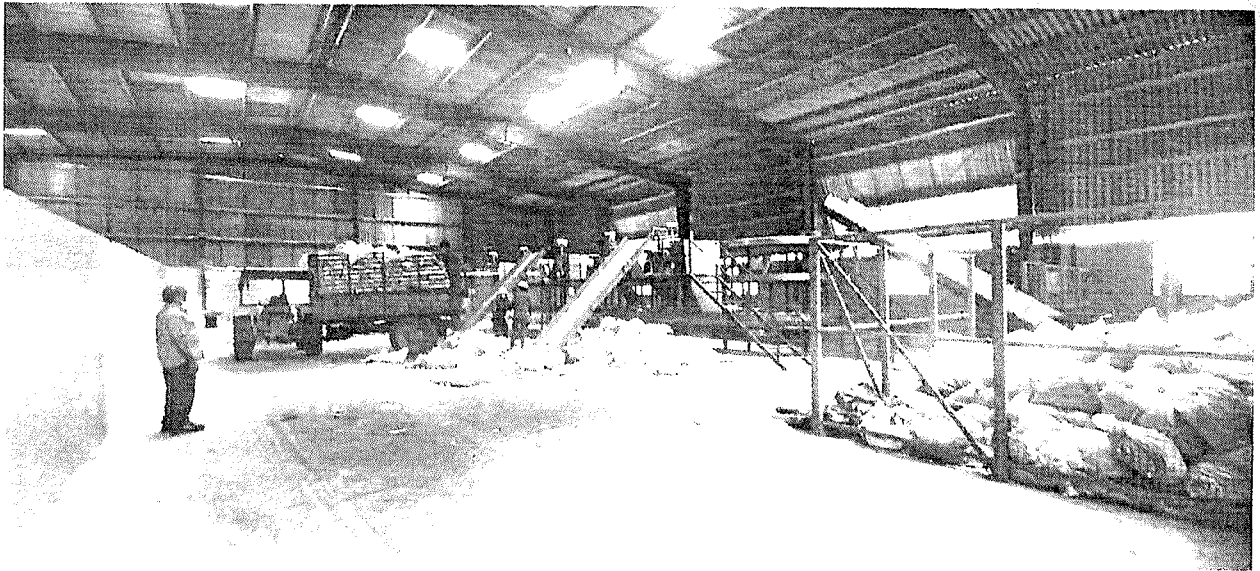
| Sl No. | DETAILS | STATUS / REMARKS |
|---|--|--|
| 5. | Barcode Scanning | Barcode scanning facility installed. There is some problem with barcode scanning facility. Site engineer informed that installed scanner doesn't work properly. |

BARCODE SCANNING AREA- CURRENTLY NOT WORKING
