## **Continuous Ambient Air Quality Monitoring Station**

**Quarterly Report (June to August 2023)**

Continuous Ambient Air Quality Monitoring Station, Trivandrum

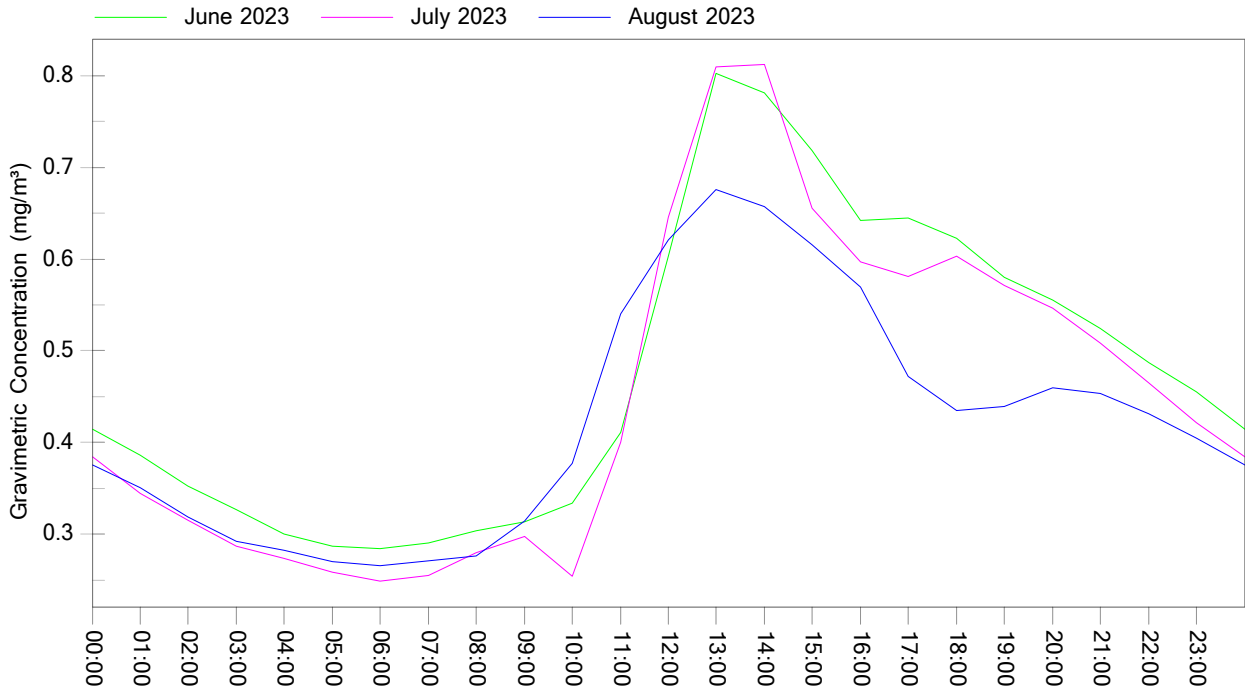
6/1/2023 to 8/31/2023

### CO(mg/m<sup>3</sup>) Line Graph

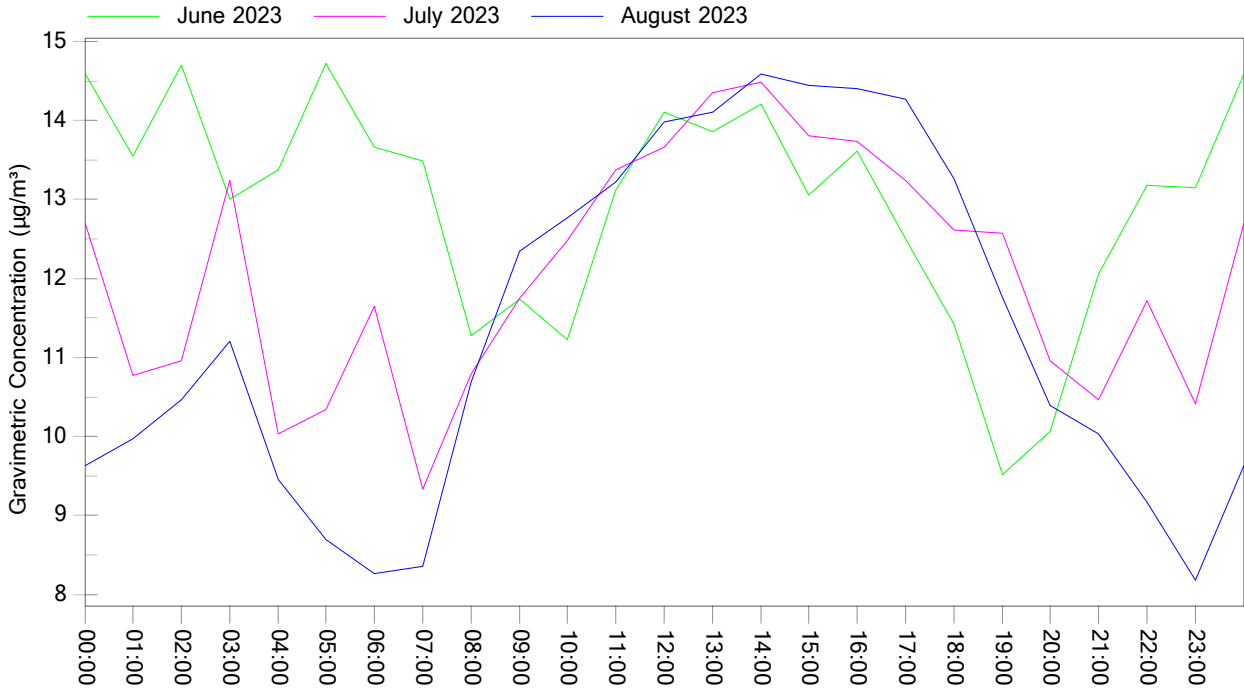
6/1/2023 to 8/31/2023

### O<sub>3</sub>( $\mu\text{g}/\text{m}^3$ ) Line Graph

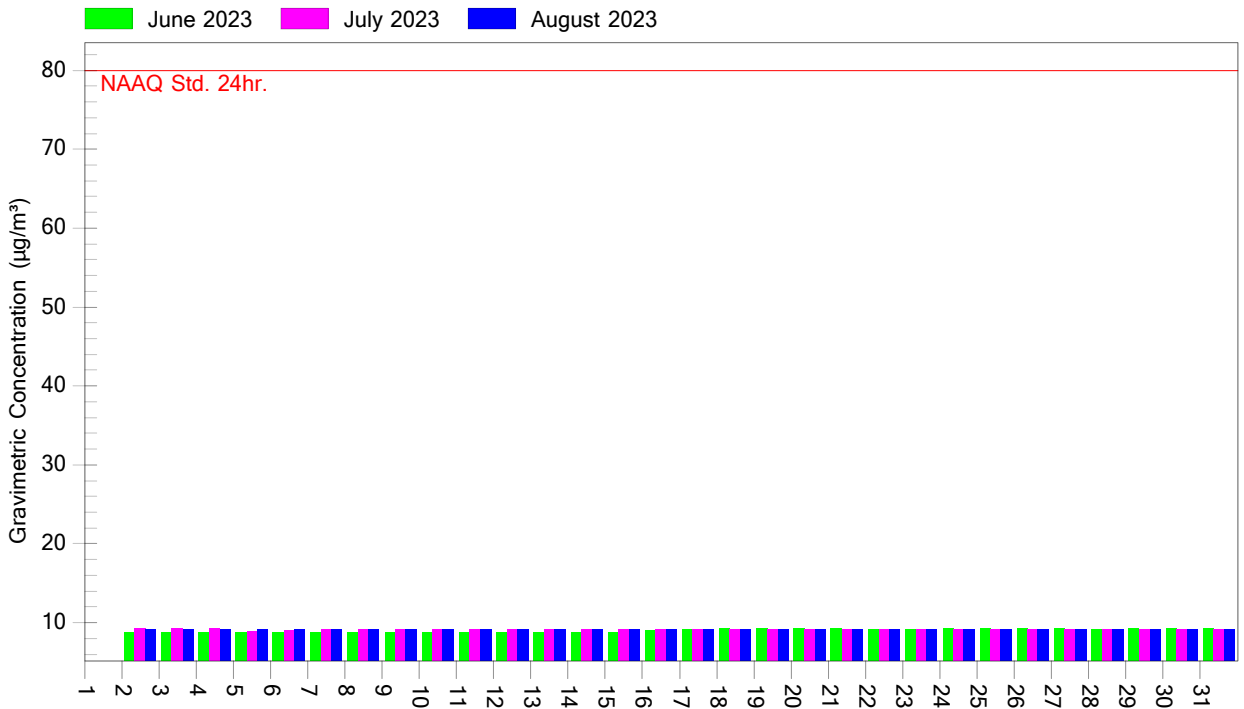
6/1/2023 to 8/31/2023

#### NO<sub>2</sub>( $\mu\text{g}/\text{m}^3$ ) Bar Graph

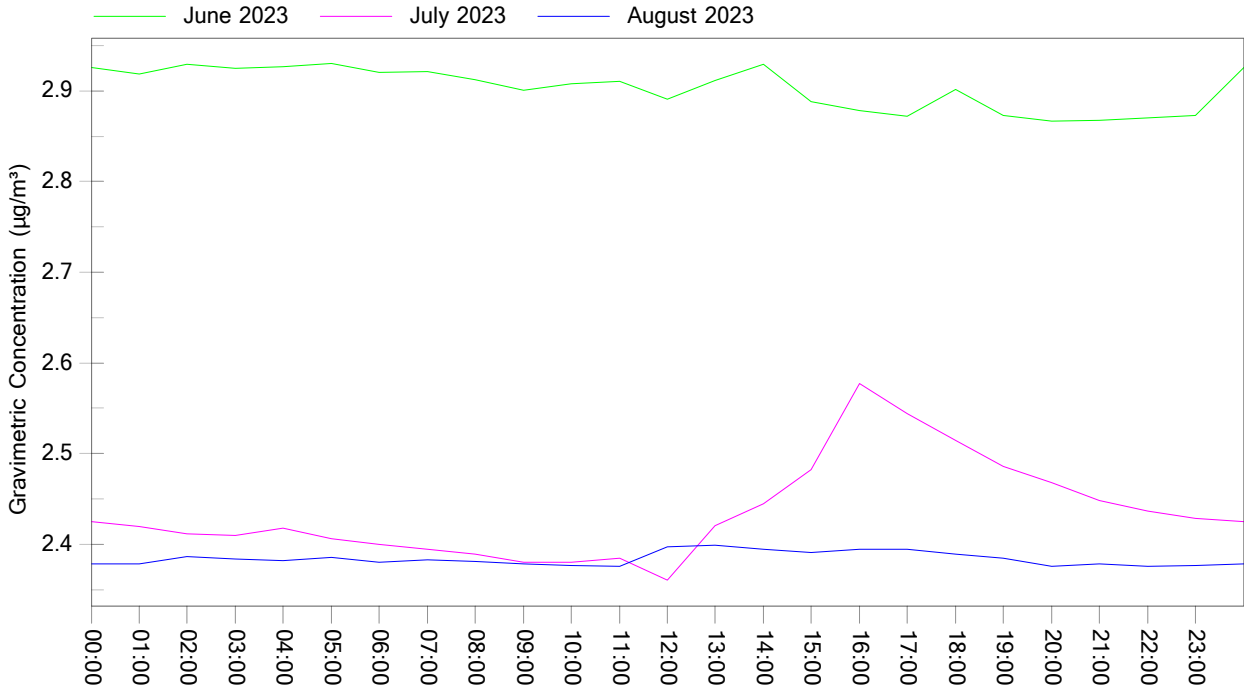
6/1/2023 to 8/31/2023

#### NH3( $\mu\text{g}/\text{m}^3$ ) Line Graph

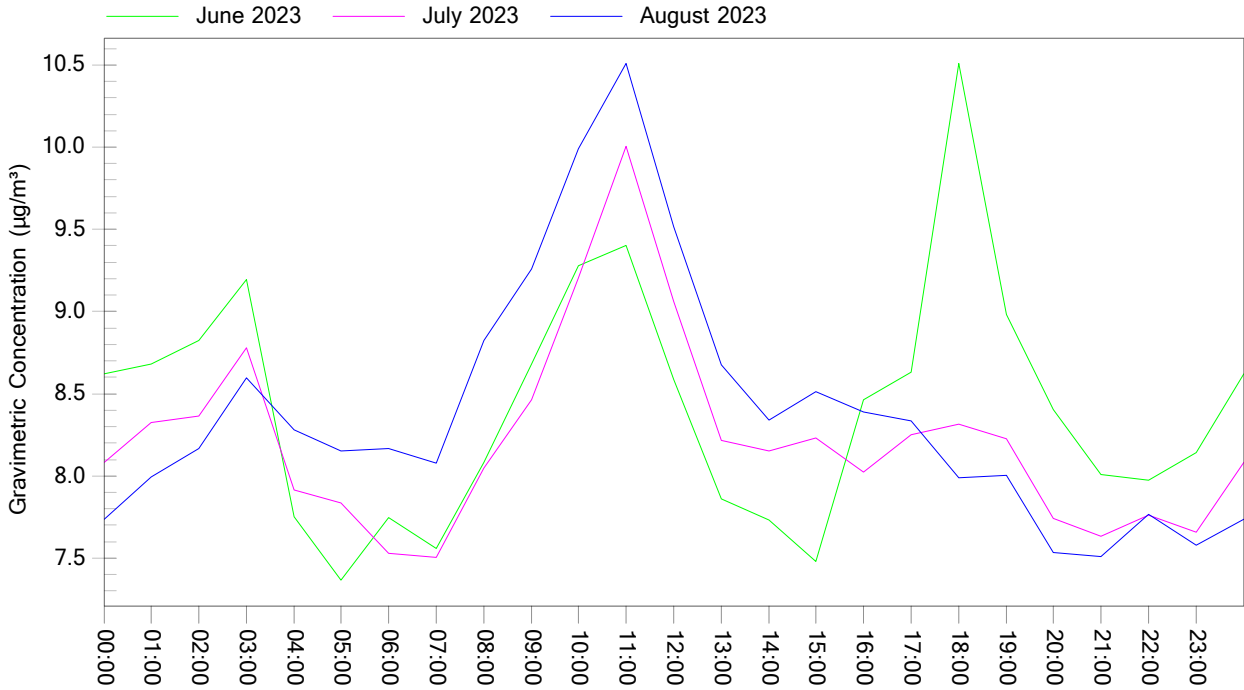
6/1/2023 to 8/31/2023

### SO<sub>2</sub>( $\mu\text{g}/\text{m}^3$ ) Line Graph

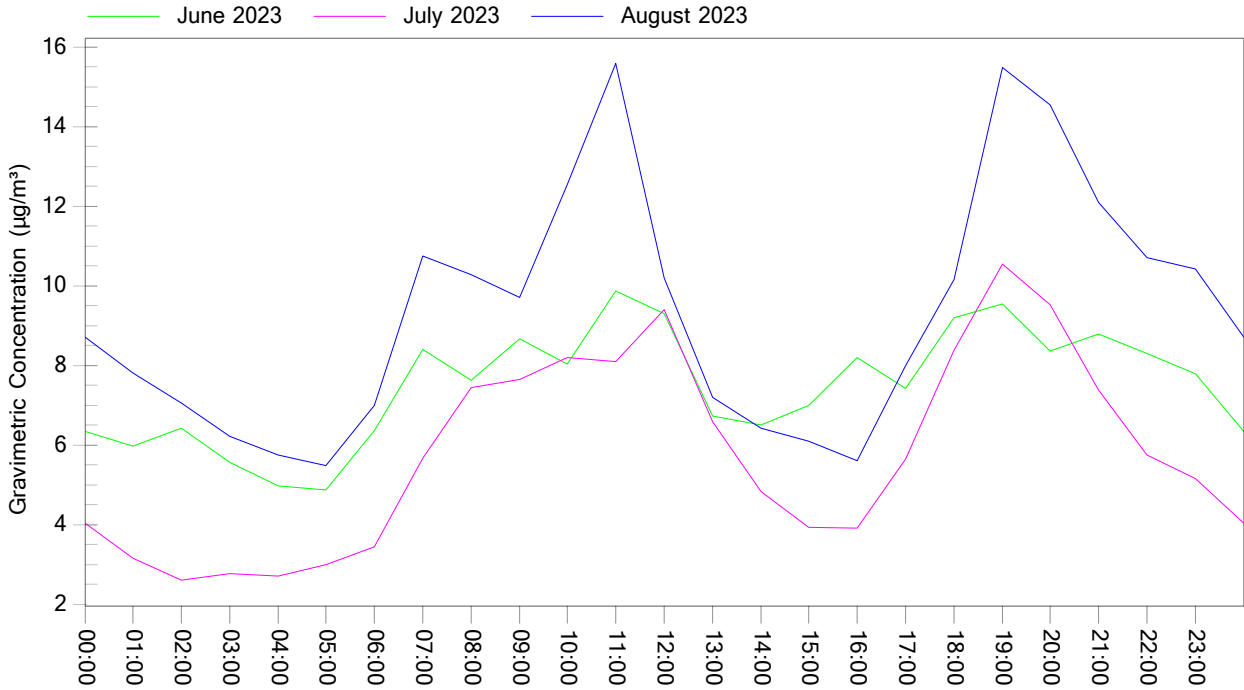
6/1/2023 to 8/31/2023

#### PM2.5( $\mu\text{g}/\text{m}^3$ ) Line Graph

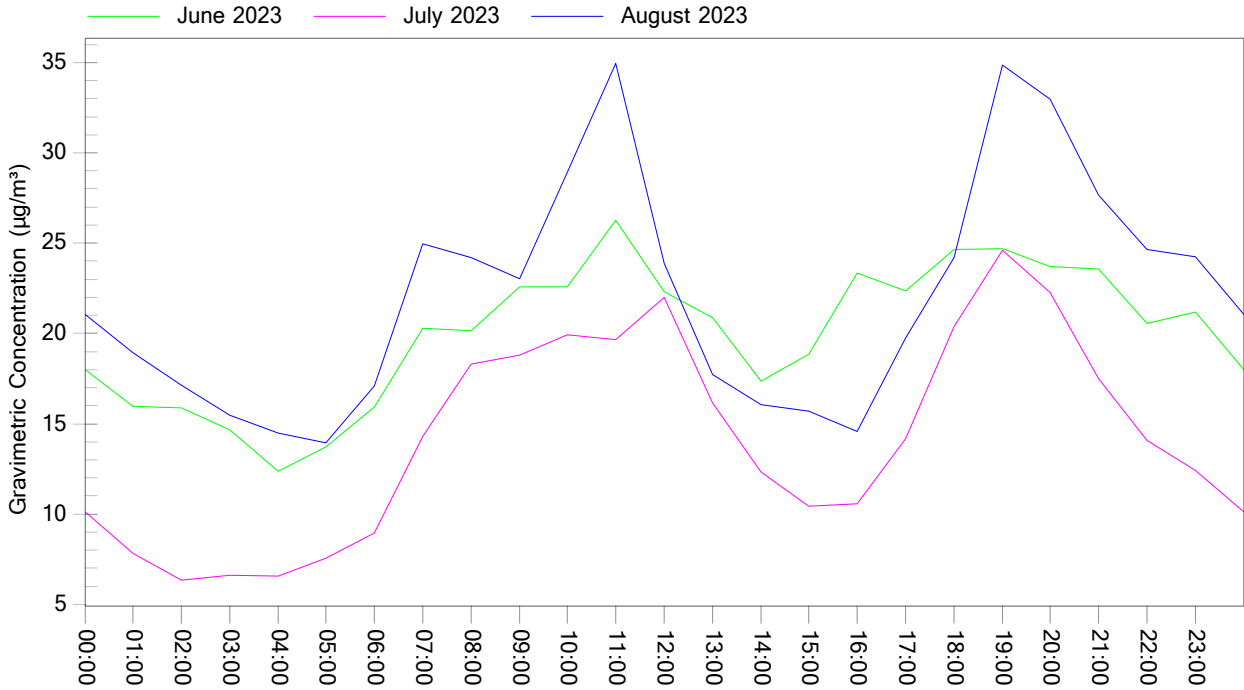
6/1/2023 to 8/31/2023

### PM10( $\mu\text{g}/\text{m}^3$ ) Line Graph

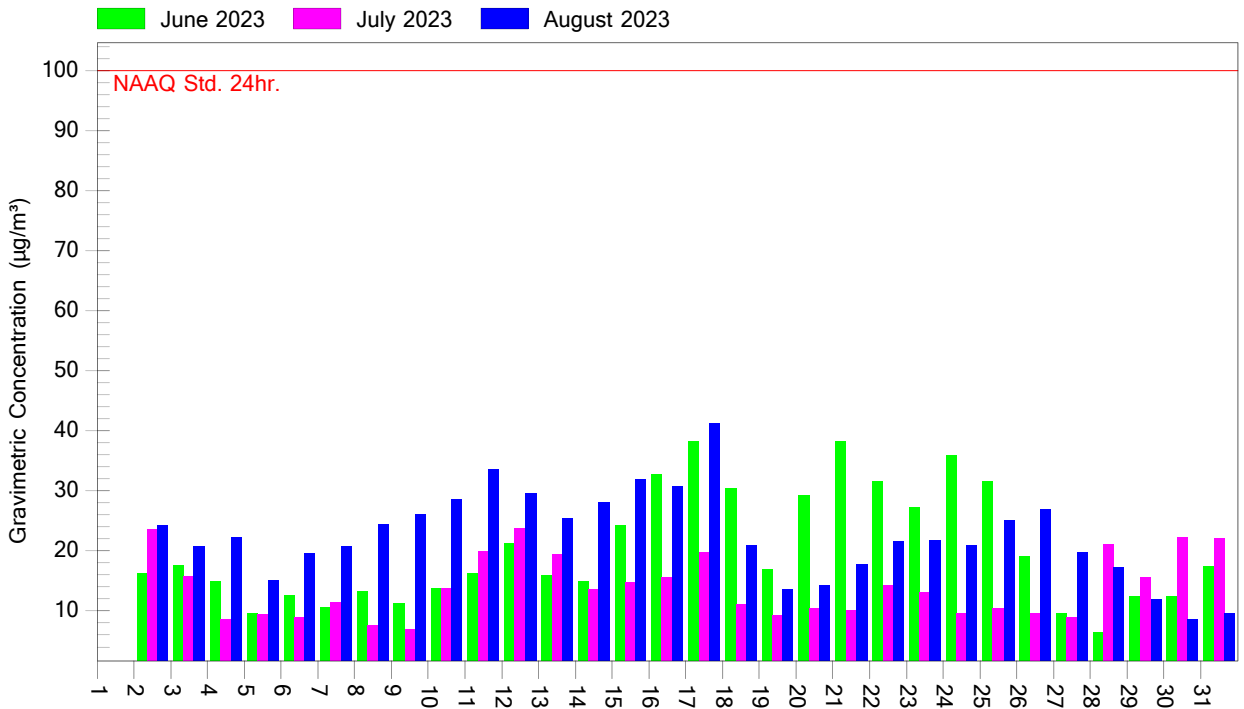
6/1/2023 to 8/31/2023

### PM10( $\mu\text{g}/\text{m}^3$ ) Bar Graph
